## EVALUATION OF CAPACITIES OF TEMPLATE-TYPE GULF OF MEXICO PLATFORMS

R. G. Bea, K. J. Loch, and P. L. Young

Department of Civil Engineering and  
Department of Naval Architecture & Offshore Engineering  
University of California  
Berkeley, California

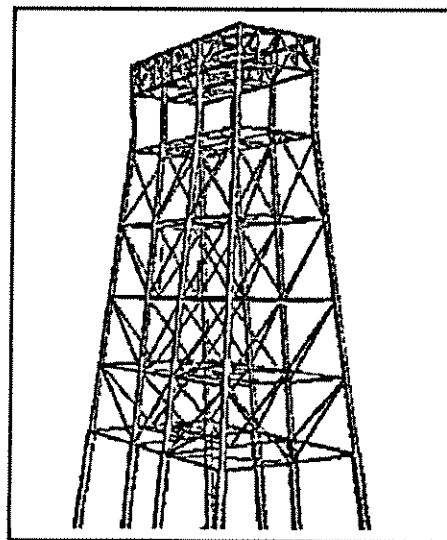
FIGURE 1: PLATFORM 'B'

Platform 'B' (PB) is a self-contained, 8-leg, drilling and production platform with 12 well slots and 9 drilled wells (Figure 1). The platform was installed in 118 ft of water in the South Timbalier region in 1964. The platform was designed according to conventional 1963 criteria based on "25-year" return period design conditions (wave height of 55 feet).

Cellar and main deck elevations were located at + 34 ft. and + 47 ft. respectively. The major deck framing is 43 ft. by 93 ft. in plan, and the jacket legs are battered at one to eight in both broadside and end-on framing. The deck legs are 36 in. in diameter with a wall thickness of 0.625 in. and are connected to the tops of the piles with welded shim connections. The 39 in. diameter legs have an average wall thickness of 0.50 in. and have no joint cans. However, gusset plates are used with the jacket leg K-joints. The broadside braces vary from 14 in. in the first of four jacket bays to 20 in. in the lowest jacket bay, while the end-on bracing varies from 14 in. to 16 in.

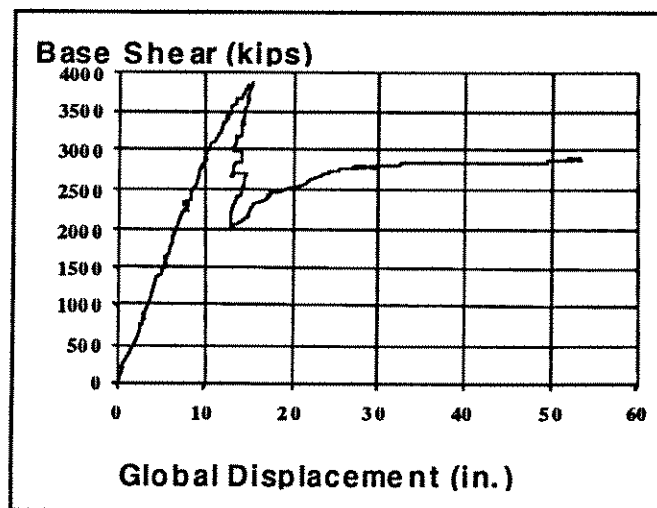
FIGURE 2: BROADSIDE FORCE-DISPLACEMENT RELATIONSHIP

The force-displacement curve for broadside loading is shown in Figure 2. This curve indicates that platform fails at 0.907 of the reference load pattern or a total base shear of 3,860 kips. This lateral loading capacity is less than the 4,900 kips reported by Imm et al. [1993]. This difference is due to the differences in the loading patterns utilized in the two analyses. The analyses reported in this paper have larger wave forces acting on the platform lower deck.

Figure 2 indicates that the platform has no reserve strength after the first brace - joint failure. However, it is important to note that the platform can experience large inelastic displacement before a failure mechanism is formed. If the force-displacement curve were extended it would show that eventually, the jacket legs develop sufficient resistance in bending to cause buckling of the braces in the third jacket bay.

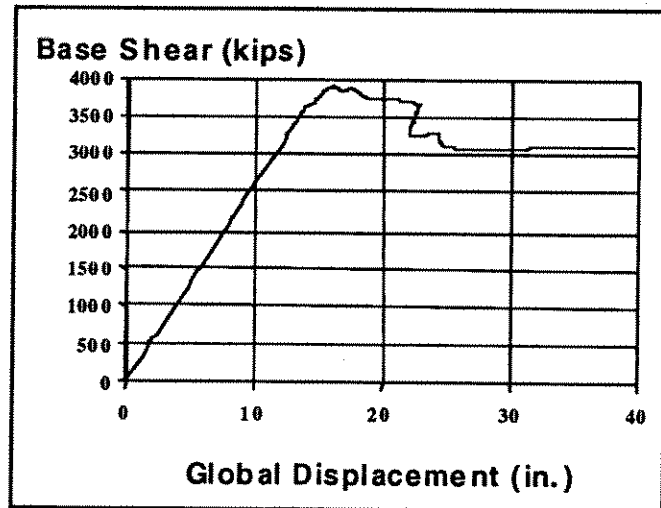
FIGURE 3: END-ON FORCE-DISPLACEMENT RELATIONSHIP

The force-displacement curve for end-on loading is shown in Figure 3. This curve indicates that the uppermost compression braces buckle at 1.12 of the reference load pattern or a total base shear of 3,900 kips. Figure 4 shows that after the compression braces - joints in the fourth jacket bay fail the platform has a small increase in resistance capacity until the compression braces in the third jacket bay and the horizontal framing between these two levels almost simultaneously fail, at which point the platform is at imminent collapse.

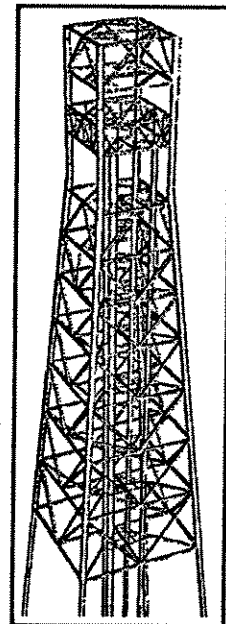
FIGURE 4: PLATFORM 'C'

Platform 'C' (PC) (Figure 4) was installed in the GOM Ship Shoal region in 1970. This platform is a self contained four pile drilling and production platform located in 157 ft. of water. PC survived hurricane Andrew without significant damage.

The platform has four conductors and eight risers. The PC decks are located at elevations of +33 ft., +43 ft., +56 ft. and +71 ft. The deck legs form a 30 ft. by 30 ft. square in plan and the jacket legs are battered at 1:11 in both primary directions.

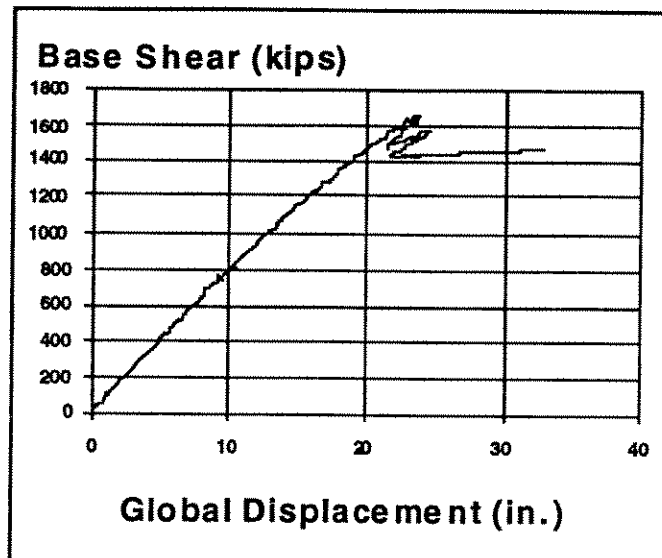
FIGURE 5 - FORCE - DISPLACEMENT RELATIONSHIP BASED ON STATIC PILE CHARACTERISTICS

The initiating failure mode for PC based on the static pile characterization is pile plunging. The force-displacement history for broadside loading is shown in Figure 5. This curve indicates that platform fails at 0.628 of the reference load pattern or a total base shear of 1,700 kips at a displacement of about 24 in. From Figure 5 it can be seen that the platform has a constant stiffness after all the T-Z and Q-Z springs of the compression piles have reached their final plateaus

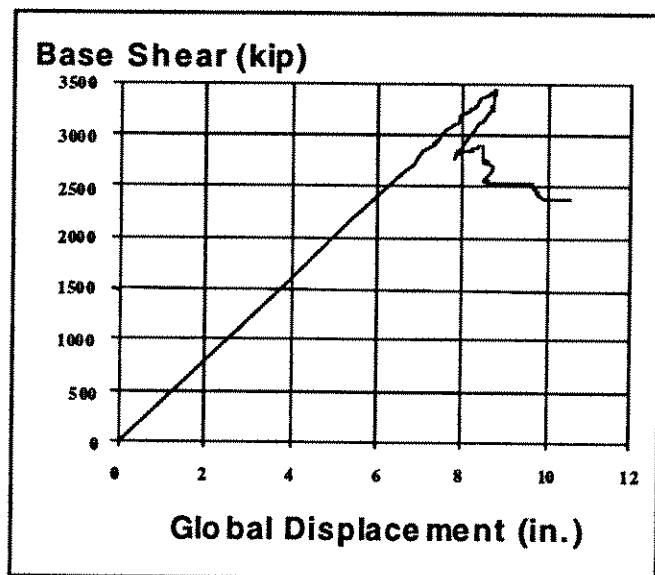
FIGURE 6: FORCE - DISPLACEMENT RELATIONSHIP FOR DYNAMIC PILE CHARACTERIZATION

The lateral force - displacement characteristics for the analyses based on the dynamic pile characterization is given in Figure 6. The peak lateral load capacity is now 3,500 kips and it is reached at a lateral displacement of about 9 in. Based on the dynamic pile characterization, the lateral load capacity of the platform is about doubled.

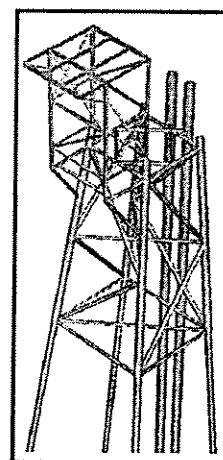
FIGURE 7: WELLHEAD PROTECTOR 1

The eye of hurricane Andrew passed within a few miles to the west of Wellhead Protectors 1 (WP1) and 2 (WP2) (Figures 7 and 8). Hurricane Andrew produced extreme storm loadings which caused WP1 to collapse. Diver surveys made after the storm indicated WP1 failed by pull out of the piles on the south side of the platform. The seemingly identical WP2 did not collapse; there was no significant damage to this structure. The goal of this study was to determine how the forces developed by hurricane Andrew could have caused the collapse of WP1 and not the collapse of WP2.

The two structures evaluated herein were both located in the South Timbalier area. The two wellhead protectors were designed and installed early in the 1980's by the same firm. The two wellhead protectors were designed according to the same API RP 2A guideline. The slightly older WP1 is located in 52 ft. of water and is oriented 45° counterclockwise from true north. WP2 is located in slightly shallower water (49 ft.) and is oriented parallel to true north. Both structures are two bay, four pile template structures designed to provide limited facilities for 36 in. diameter caisson well risers (Figures 7 and 8). Both protectors have offset braced heli-pads and boat landings for easy access.

The jacket framing of the two structures is almost identical, with WP2 having slightly smaller diameter jacket legs and piles; 28 and 24 in., as opposed to 30 and 26 in. Diagonal vertical bracing is made up of 18 in. tubulars, while plan bracing is composed of 12.75 in. tubulars on all three levels. All members were fabricated using A36 grade steel.

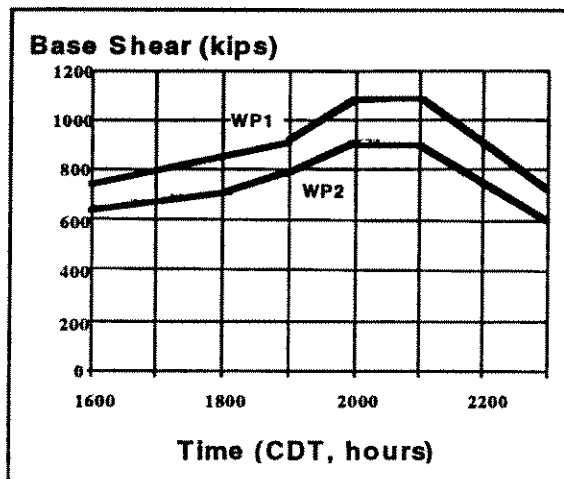
FIGURE 9: TIME HISTORY OF MAXIMUM BASE SHEARS ON WP1 AND WP2 DURING HURRICANE ANDREW

The two structures were loaded only along their principal axes to provide consistency between the various approaches employed to analyze structural response. Wave loads for USFOS were generated by the seastate program WAJAC [DNV 1993] which determines peak loads using phase angle intervals of  $1^\circ$ . The global base shears developed on WP1 and WP2 during the passage of Andrew are summarized in Figure 9. The results indicate WP1 experienced peak lateral loadings that were about 20 % larger than those on WP2. The peak lateral loading on WP1 was 1,100 kips and on WP2 was 850 kips.

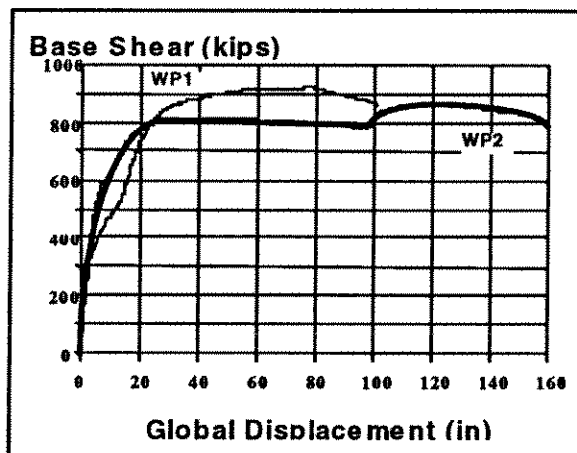
FIGURE 10: LOAD - DISPLACEMENT CHARACTERISTICS FOR WP1 AND WP2

The static push-over results for WP1 and WP2 based on the USFOS results are summarized in Figure 10. The "double humps" found in both analyses result from the increased stiffness of the structures when contact between the jacket and caissons occur. The negative stiffness found at the end of all analyses represents pile pullout. The large lateral deformations produce plastic hinges in the piles which produce a near mechanism. It is the additional strength and rigidity of the caissons which prevents the structures from soft story collapse. This added stiffness allows the full axial capacity of the soils to be exceeded to produce pile pullout. The maximum lateral load capacity of WP1 is 910 kips and WP2 880 kips.

The USFOS result that both structures fail due to pile yielding and pullout was confirmed by results from the StruCad\*3D and ULSLEA analyses. The ratio of the peak lateral loading during hurricane Andrew to the maximum lateral loading capacity is 1.2 and 0.95 for WP1 and WP2, respectively. The analyses indicate that WP1 should have failed due to pile pullout and WP2 should have survived. The paradox of why these two seemingly identical structures behaved differently was due to the differences in the appurtenances (well conductors), the manner in which the wells were tied into the structures, and the under-driven piles. The effects of these differences only
